**Flood Control Project Maintenance
Levee Inspections**

Fall 2018 Levee Maintenance Deficiency Summary Report

San Joaquin River Basin

**Flood Control Project Maintenance
Levee Inspections****LMA District Cover Sheet****Fall 2018 Levee Inspection Results****Reclamation District No. 0524 Middle Roberts Island**

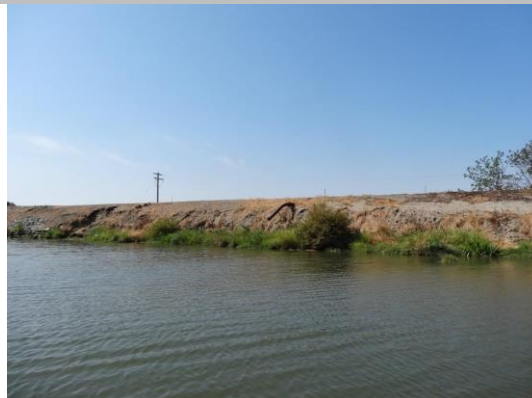
Photo 2 of 4 : FA_2018_RD0524_107_47_20180906_00085.jpg

LM Start	1.27	Rating **	A/W	Issue No.	47 (cont)
LM End	1.30	Issue Type +	Ma	Location *	WS
Category	Supplemental			GPS Latitude/Longitude	
				Start	End
Item	DWR Erosion Survey			37.931858 °	37.931887 °
				-121.328300 °	-121.328343 °
DWR ID	RD0524U01RM41.92				
Comment Code					
Inspector Comment					
5/17/2018. LM 1.30-1.31 was repaired by DWR the remainder of the site was un affected.					
09/13/2017. The erosion has developed along the levee slope. The length of the erosion is nearly doubled comparing to the prior survey.					
07/25/2016: No significant change observed.					
06/24/2015: No significant change observed.					
06/19/2014: No significant change observed.					
08/13/2013: New signs of animal activity were found.					
08/07/2012: The site was first reported in 2012 spring levee inspection report. [2017 Site ID:RD0524U01RM41.92]

Front view of the erosion.

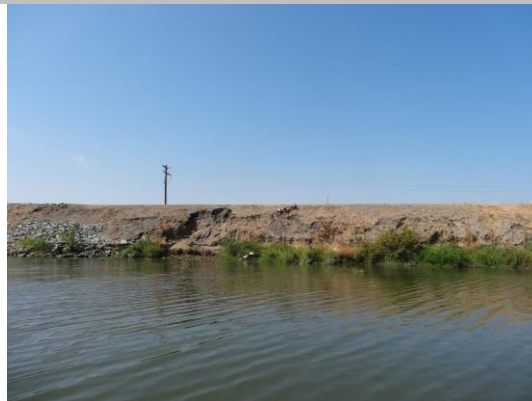
Photo 3 of 4 : FA_2018_RD0524_107_47_20180906_00086.jpg

Close view of the erosion.

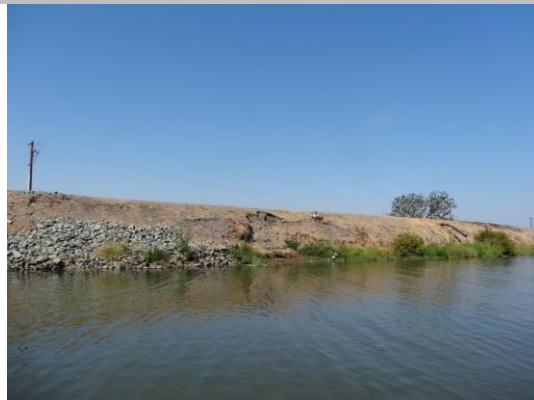
Photo 4 of 4 : FA_2018_RD0524_107_47_20180906_00087.jpg

LM Start	1.27	Rating **	A/W	Issue No.	47 (cont)	
LM End	1.30	Issue Type +	Ma	Location *	WS	
Category	Supplemental			GPS Latitude/Longitude		
				Start	End	
Item	DWR Erosion Survey			37.931858 °	37.931887 °	
				-121.328300 °	-121.328343 °	
DWR ID	RD0524U01RM41.92					
Comment Code						
Inspector Comment						
5/17/2018. LM 1.30-1.31 was repaired by DWR the remainder of the site was un affected.						
09/13/2017. The erosion has developed along the levee slope. The length of the erosion is nearly doubled comparing to the prior survey.						
07/25/2016: No significant change observed.						
06/24/2015: No significant change observed.						
06/19/2014: No significant change observed.						
08/13/2013: New signs of animal activity were found.						
08/07/2012: The site was first reported in 2012 spring levee inspection report. [2017 Site ID:RD0524U01RM41.92]

Front view of the erosion. Note the worsen erosion next to the protected slope.

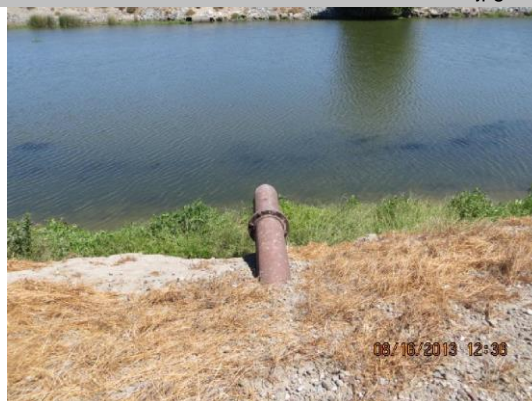
Photo 1 of 3 : UCIP_FA_2018_53162_29862.jpg

Comment Code					
Inspector Comment					
FS_ID:53162 DS_ID:20602 EP_NO: N/A Repair Type: Non-Urgent Crossing Status: Found UCIP Comments: 10/2/2018 Pipe appears abandoned, but both the pipe and levee appear in good condition; downgrading to Non-Urgent (D. Sanoski - DWR UCIP).11/16/2016 same as previous inspection both ends are open. This pipe does not appear in use. Need to contact owner to determine status of crossing. If the crossing is abandoned or in use, owner will need to coordinate with the CVFPB to comply with Title 23 requirements. (O. Magana - DWR UCIP)08/16/2013 Pipe appears to be open on both ends. Abandoned and should be done so properly. (W. Wylie - DWR UCIP) FIELD_STRUCT_DESC: *ABANDONED* 12-inch steel drainage pipe through the levee, 3.5 feet below the crown. Pipe is opened on the waterside (WS) and landside (LS) ends. The pump house referenced in O&M manual is missing from the LS (2013). [Additional Reference(s): DWR Levee Log, 2004. USACE San Joaquin O&M Manual 7, April 1964, (HLM 1.31)]. FS Date: 10/2/2018 1:10:16 PM

Pipe visible and open on WS slope.

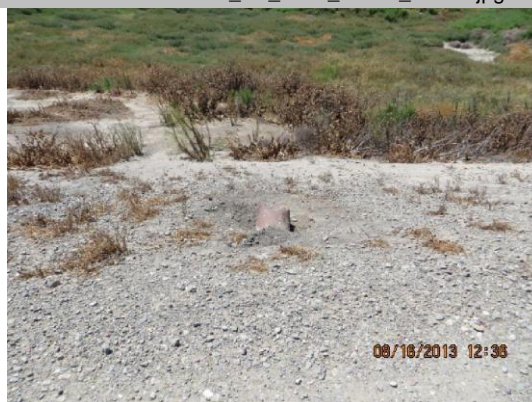
Photo 2 of 3 : UCIP_FA_2018_53162_29861.jpg

Pipe open and visible on LS slope.

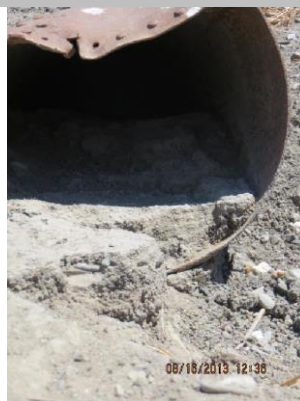
Photo 3 of 3 : UCIP_FA_2018_53162_29860.jpg

Comment Code						
Inspector Comment						
FS_ID:53162 DS_ID:20602 EP_NO: N/A Repair Type: Non-Urgent Crossing Status: Found UCIP Comments: 10/2/2018 Pipe appears abandoned, but both the pipe and levee appear in good condition; downgrading to Non-Urgent (D. Sanoski - DWR UCIP).11/16/2016 same as previous inspection both ends are open. This pipe does not appear in use. Need to contact owner to determine status of crossing. If the crossing is abandoned or in use, owner will need to coordinate with the CVFPB to comply with Title 23 requirements. (O. Magana - DWR UCIP)08/16/2013 Pipe appears to be open on both ends. Abandoned and should be done so properly. (W. Wylie - DWR UCIP) FIELD_STRUCT_DESC: *ABANDONED* 12-inch steel drainage pipe through the levee, 3.5 feet below the crown. Pipe is opened on the waterside (WS) and landside (LS) ends. The pump house referenced in O&M manual is missing from the LS (2013). [Additional Reference(s): DWR Levee Log, 2004. USACE San Joaquin O&M Manual 7, April 1964, (HLM 1.31)]. FS Date: 10/2/2018 1:10:16 PM

Pipe appears open on both ends. View from LS slope.

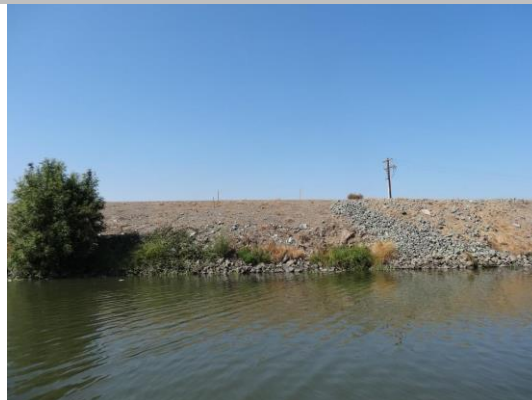
Photo 1 of 2 : FA_2018_RD0524_107_55_20180906_00096.jpg

LM Start	1.33	Rating **	M	Issue No.	55							
LM End	1.33	Issue Type +	Ma	Location *	WS							
Category	Supplemental		GPS Latitude/Longitude									
			Start	End								
Item	DWR Erosion Survey		37.931510°	37.931510°								
			-121.328120°	-121.328120°								
DWR ID	RD0524U01RM41.95											
Comment Code												
Inspector Comment												
09/13/2017: The erosion is located immediately upstream of a protected levee section. [2017 Site ID: RD0524U01RM41.95]

Front view of the erosion.

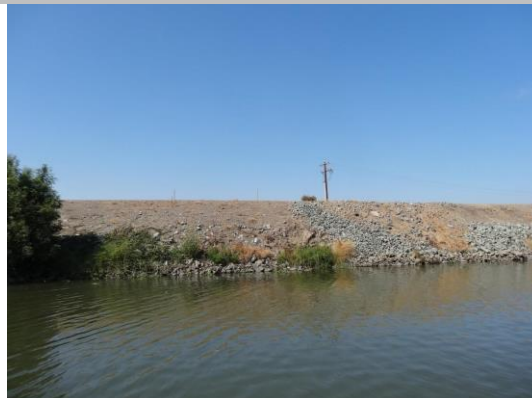
Photo 2 of 2 : FA_2018_RD0524_107_55_20180906_00097.jpg

LM Start	1.33	Rating **	M	Issue No.	55 (cont)	
LM End	1.33	Issue Type +	Ma	Location *	WS	
Category	Supplemental			GPS Latitude/Longitude		
				Start		End
Item	DWR Erosion Survey			37.931510 °	37.931510 °	
				-121.328120 °	-121.328120 °	
DWR ID	RD0524U01RM41.95					
Comment Code						
Inspector Comment						
09/13/2017: The erosion is located immediately upstream of a protected levee section. [2017 Site ID:RD0524U01RM41.95]

Front view of the erosion.

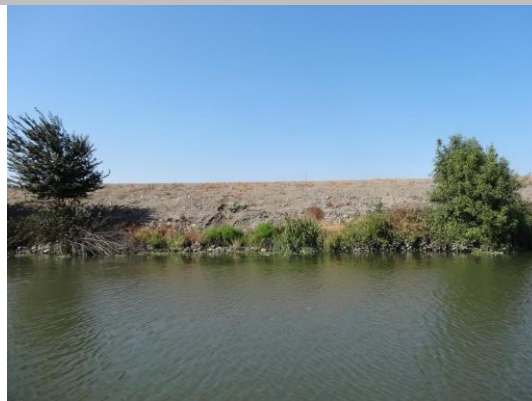
Photo 1 of 3 : FA_2018_RD0524_107_56_20180906_00098.jpg

LM Start	1.39	Rating **	U	Issue No.	56
LM End	1.39	Issue Type +	Ma	Location *	WS
Category	Supplemental			GPS Latitude/Longitude	
				Start	End
Item	DWR Erosion Survey			37.930575 °	37.930575 °
				-121.328090 °	-121.328090 °
DWR ID	RD0524U01RM42.03				
Comment Code					
Inspector Comment					
09/13/2017: No significant change observed					
07/25/2016: No significant change observed					
06/24/2015: No significant change observed.					
06/19/2014: No significant change observed.					
08/13/2013: No significant change observed.					
08/07/2012: The site was first reported in 2012 spring levee inspection					
report. The site is located about 750 ft downstream of SR 4 Bridge.					
[2017 Site ID:RD0524U01RM42.03]

Front view of the erosion.

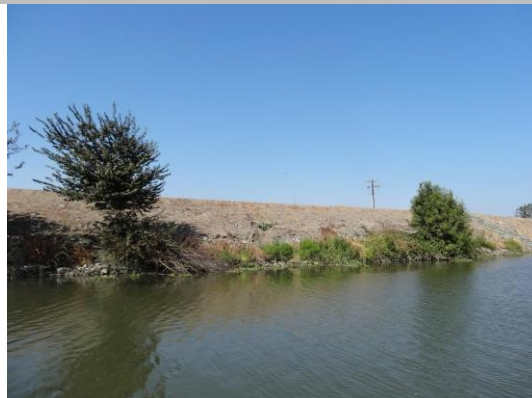
Photo 2 of 3 : FA_2018_RD0524_107_56_20180906_00099.jpg

Front view of the erosion.

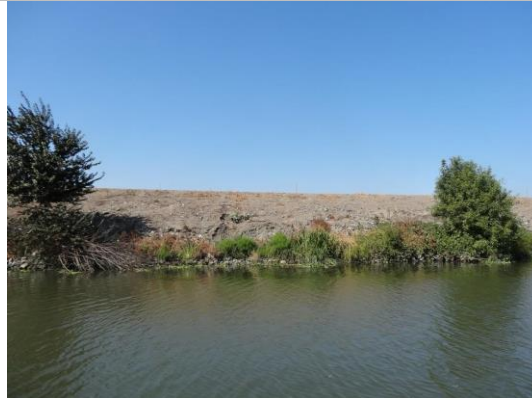
Photo 3 of 3 : FA_2018_RD0524_107_56_20180906_00100.jpg

Close view of the erosion.

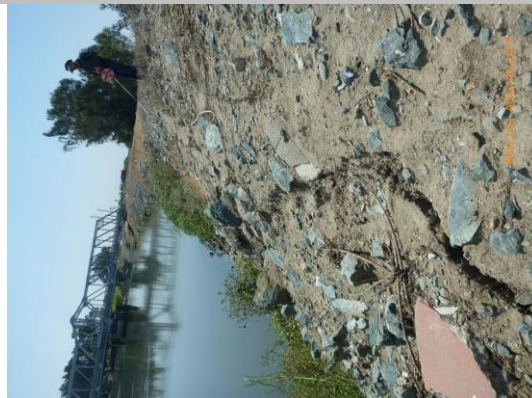
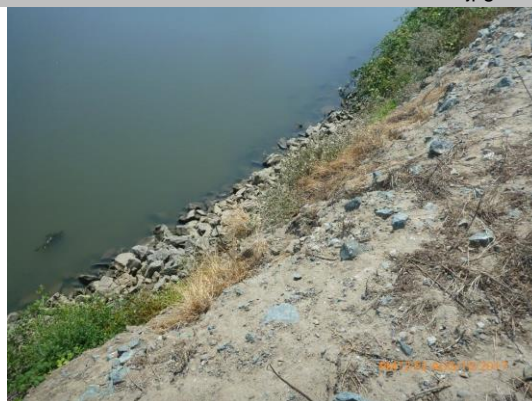
LM Start	1.43	Rating **	A/W	Issue No.	226
LM End	1.44	Issue Type +	Ma	Location *	
Category	Supplemental			GPS Latitude/Longitude	
				Start	End
Item	2017 Storm Damage			37.930100 °	37.929900 °
				-121.328300 °	-121.328300 °
DWR ID	DWR_RD0524_01_f_2017_226				
Comment Code					
Inspector Comment					
Levee Evaluation Comments					
Description:Slope protection repairs are needed along the waterside slope due to erosion and riprap displacement from high water. Based upon levee inspections, it was determined the waterside levee slope is eroding, deteriorating, and degrading. The eroded levee sections need to be restored back to design standards to prevent further deterioration and damage.					
Site ID No:530					
Site Designation:LMA-436					
Repair Type: Erosion					
Rating:Area of Concern					
Field Date:8/10/2017					
Notes:

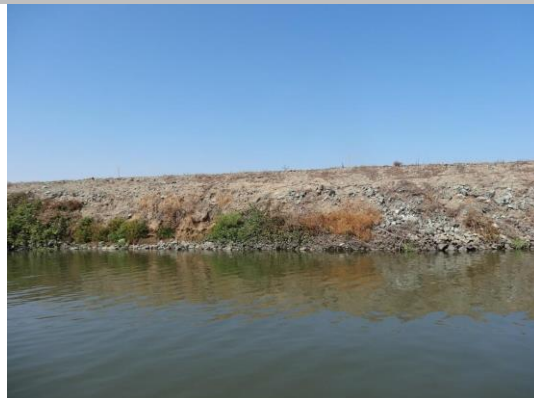
Photo 2 of 4 : FA_2018_RD0524_107_60_20180906_00107.jpg

LM Start	1.45	Rating **	U	Issue No.	60
LM End	1.47	Issue Type +	Ma	Location *	WS
Category	Supplemental			GPS Latitude/Longitude	
				Start	End
Item	DWR Erosion Survey			37.929650 °	37.929650 °
				-121.328110 °	-121.328110 °
DWR ID	RD0524U01RM42.09				
Comment Code					
Inspector Comment					
09/13/2017: No significant change observed.					
07/25/2016: No significant change observed.					
06/24/2015: No significant change observed.					
06/19/2014: No significant change observed.					
08/13/2013: The site is located approximately 400 ft. downstream SR 4 Bridge. Dense vegetation is visible at the toe. [2017 Site ID:RD0524U01RM42.09]

Front view of the erosion.

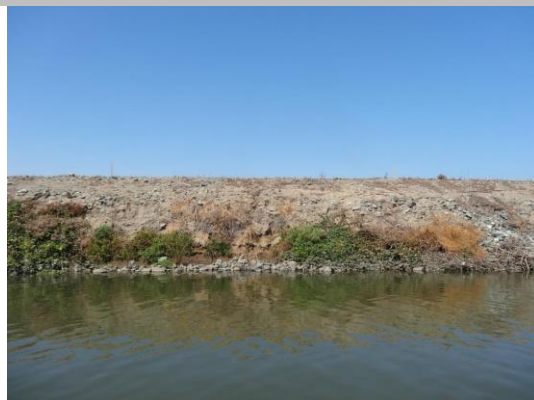
Photo 3 of 4 : FA_2018_RD0524_107_60_20180906_00108.jpg

Close view of the erosion. Note the vegetation at the site.

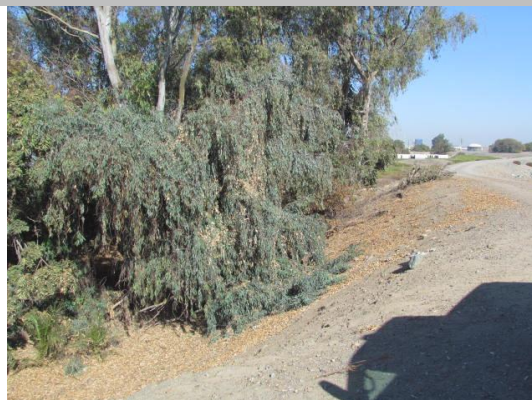
Photo 1 of 1 : FA_2018_RD0524_107_916_20180906_00360.jpg

LM Start	1.49	Rating **	U	Issue No.	916
LM End	1.49	Issue Type +	Ma	Location *	LS
Category	Earthen Levee			GPS Latitude/Longitude	
				Start	End
Item	Trim / Thin Trees			37.929118 °	37.929118 °
				-121.328368 °	-121.328368 °
DWR ID	DWR_RD0524_01_s_2012_916				
Comment Code					
T3 : Trim and thin trees to allow visibility of the ground and room to flood fight.					
Inspector Comment					
Untrimmed trees and dense vegetation on landside toe.

Looking at dense trees on landward slope and toe fall 2015

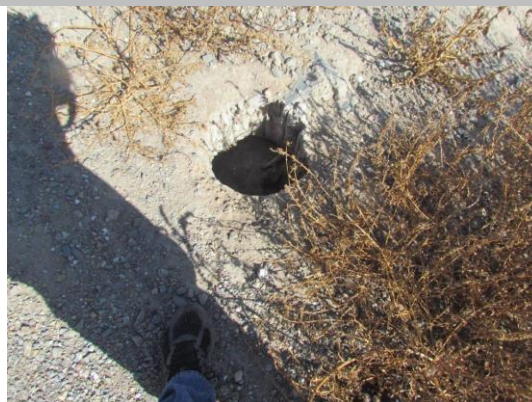
Photo 1 of 2 : FA_2018_RD0524_107_202_20180906_00267.jpg

LM Start	1.55	Rating **	U	Issue No.	202
LM End	1.55	Issue Type +	Ma	Location *	WS
Category	Earthen Levee			GPS Latitude/Longitude	
				Start	End
Item	Erosion / Bank Caving			37.928391 °	37.928391 °
				-121.328273 °	-121.328273 °
DWR ID	DWR_RD0524_01_f_2016_202				
Comment Code					
E2 : Schedule repair of erosion site prior to the next inspection.					
Inspector Comment					
Large hole (looks like fences post or telephone pole) on waterside shoulder.

Looking at large hole (Fence/telephone post hole) on waterward shoulder.

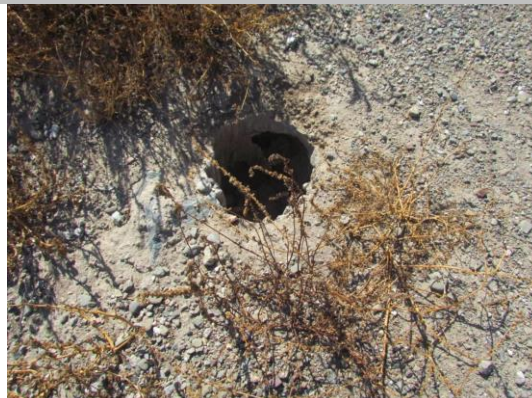
Photo 2 of 2 : FA_2018_RD0524_107_202_20180906_00268.jpg

Looking at hole on waterward shoulder.

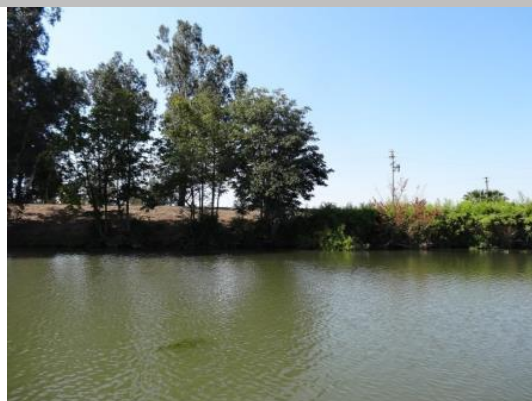
Photo 1 of 3 : FA_2018_RD0524_107_62_20180906_00111.jpg

Comment Code						
Inspector Comment						
09/13/2017: No significant change observed.						
07/25/2016: No significant change observed.						
06/24/2015: No significant change observed.						
06/19/2014: No significant change observed.						
08/13/2013: No significant change observed.						
08/07/2012: The site has been visited by boat survey. No significant change observed						
08/23/2011: No significant change observed on site. Trees concerned still in place.						
09/07/2010: No significant change observed on site. The concern here is the undermining of the levee toe where most of trees are. There are erosion pockets lined along the lower slope and at the base of the trees, exposing tree roots. There is minimal slope protection.						
09/29/2009: The lower slope is lined with minor erosion pockets; some tree roots are exposed; there is visible undermining of the levee toe; site is immediately upstream of the Highway 4 Bridge; the bridge is possibly causing a scour to occur, eroding the bank. [2017 Site ID:RD0524U01RM42.2]

Front view of the site where undermining has occurred.

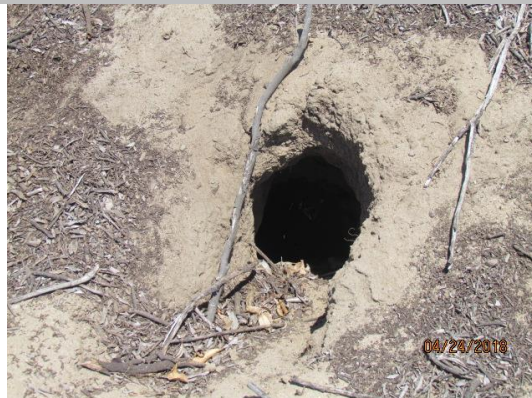
Photo 1 of 2 : FA_2018_RD0524_107_151_20180906_00194.jpg

LM Start	1.59	Rating **	A/W	Issue No.	151
LM End	1.61	Issue Type +	Ma	Location *	LS
Category	Earthen Levee			GPS Latitude/Longitude	
				Start	End
Item	Animal Control			37.927680°	37.927512°
				-121.328004°	-121.327815°
DWR ID	DWR_RD0524_01_s_2018_151				
Comment Code					
A3 : No rodents visible, but rodent burrows visible; need to backfill and compact or grout burrows.					
Inspector Comment					
Several large rodent holes on landward slope. Backfilled rodent hole. No rodent program present.

Looking at close-up view of large rodent hole on landward slope. (Spring 2018)

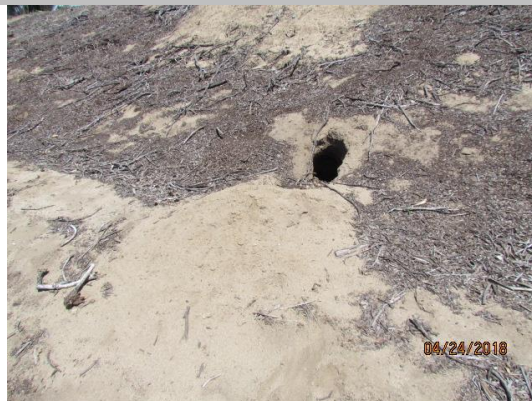
Photo 2 of 2 : FA_2018_RD0524_107_151_20180906_00195.jpg

Looking east at large rodent hole on landward slope. (Spring 2018)

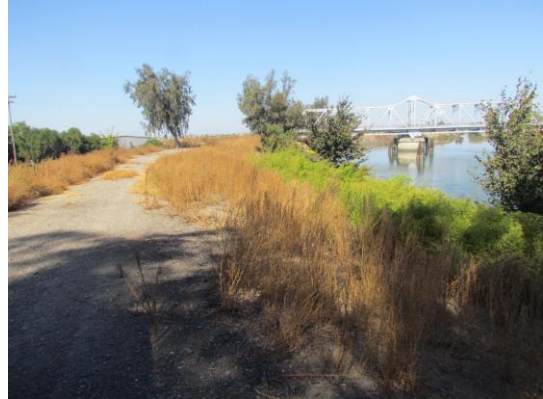
Photo 1 of 3 : FA_2018_RD0524_107_25_20180906_00042.jpg

Looking northwest at dense veg on waterward slope.

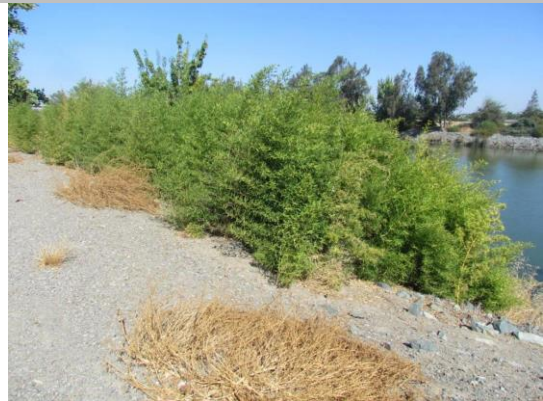
Photo 2 of 3 : FA_2018_RD0524_107_25_20180906_00043.jpg

Looking northwest at end of dense veg on waterward slope.

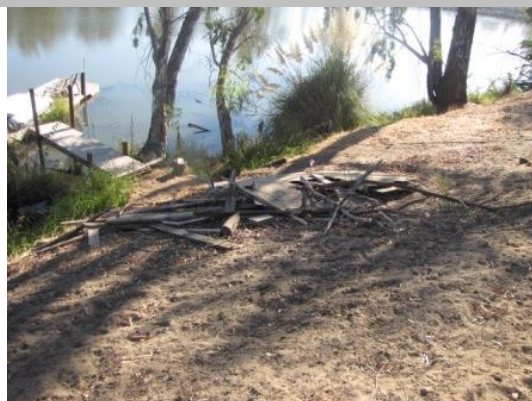
Photo 1 of 2 : FA_2018_RD0524_107_39_20180906_00066.jpg

Looking at garbage on waterside slope.

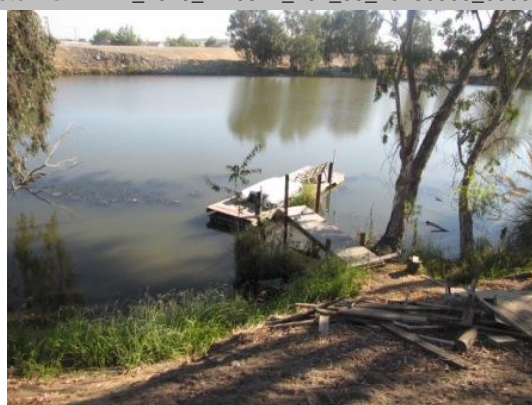
Photo 2 of 2 : FA_2018_RD0524_107_39_20180906_00067.jpg

LM Start	1.64	Rating **	U	Issue No.	39
LM End	1.64	Issue Type +	En	Location *	WS
Category	Earthen Levee			GPS Latitude/Longitude	
				Start	End
Item	Encroachments			37.927372°	37.927372°
				-121.327278°	-121.327278°
DWR ID	DWR_RD0524_01_s_2012_39				
Comment Code					
ST : Stairway					
Inspector Comment					
Landowner constructed boat dock without permit.

Looking east at non-permitted boat dock.

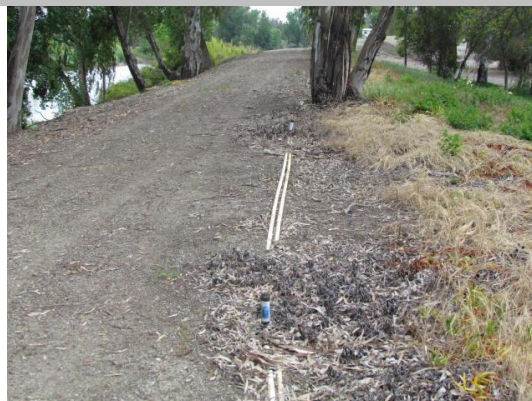
Photo 1 of 2 : FA_2018_RD0524_107_207_20180906_00273.jpg

LM Start	1.65	Rating **	M	Issue No.	207
LM End	1.71	Issue Type +	En	Location *	LS
Category	Earthen Levee			GPS Latitude/Longitude	
				Start	End
Item	Encroachments			37.927237°	37.926621°
				-121.327183°	-121.326400°
DWR ID	DWR_RD0524_01_s_2016_207				
Comment Code					
LI : Landscape Irrigation					
Inspector Comment					
Sprinklers on landside shoulder

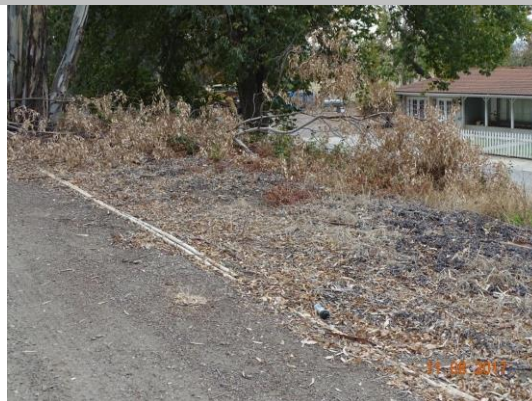
Photo 1 of 1 : FA_2018_RD0524_107_240_20180906_00335.jpg

LM Start	1.66	Rating **	M	Issue No.	240
LM End	1.66	Issue Type +	Ma	Location *	LS
Category	Earthen Levee			GPS Latitude/Longitude	
				Start	End
Item	Encroachments			37.927159 °	37.927159 °
				-121.327022 °	-121.327022 °
DWR ID	DWR_RD0524_01_f_2017_240				
Comment Code					
TR : Tree or limb					
Inspector Comment

Looking southeast at the landside slope.

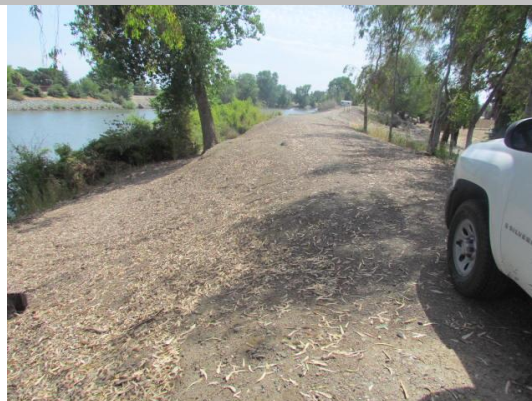
Photo 1 of 1 : FA_2018_RD0524_107_27_20180906_00048.jpg

LM Start	1.69	Rating **	M	Issue No.	27
LM End	1.70	Issue Type +	Ma	Location *	WS
Category	Earthen Levee			GPS Latitude/Longitude	
				Start	End
Item	Slope Stability			37.926728 °	37.926730 °
				-121.326597 °	-121.326508 °
DWR ID	DWR_RD0524_01_s_2012_27				
Comment Code					
S1 : Repair slope instability.					
Inspector Comment					
Slope damage several feet long and greater than one inch deep.

Looking south at landward slope depression.

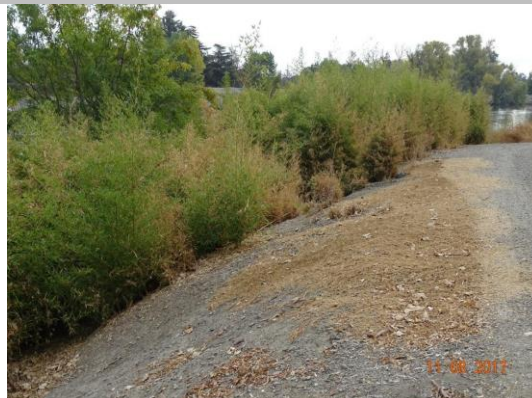
Photo 1 of 1 : FA_2018_RD0524_107_243_20180906_00337.jpg

LM Start	1.71	Rating **	U	Issue No.	243
LM End	1.72	Issue Type +	Ma	Location *	WS
Category	Earthen Levee			GPS Latitude/Longitude	
				Start	End
Item	Vegetation			37.926638 °	37.926471 °
				-121.326374 °	-121.326175 °
DWR ID	DWR_RD0524_01_f_2017_243				
Comment Code					
V2 : Remove the wild growth other than native grasses from the levee slopes.					
Inspector Comment

Looking southeast at the waterside slope.

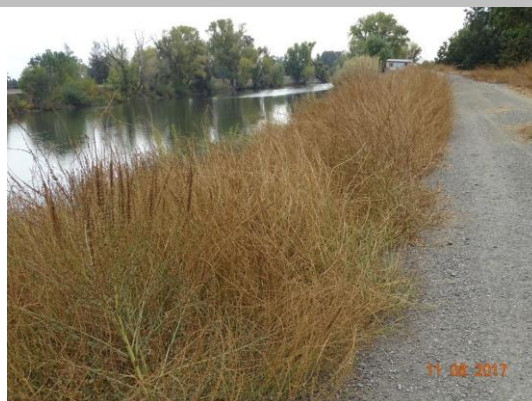
Photo 1 of 1 : FA_2018_RD0524_107_244_20180906_00338.jpg

LM Start	1.73	Rating **	U	Issue No.	244
LM End	1.75	Issue Type +	Ma	Location *	WS
Category	Earthen Levee			GPS Latitude/Longitude	
				Start	End
Item	Vegetation			37.926395 °	37.926191 °
				-121.326125 °	-121.325952 °
DWR ID	DWR_RD0524_01_f_2017_244				
Comment Code					
V2 : Remove the wild growth other than native grasses from the levee slopes.					
Inspector Comment

Looking southeast at the waterside slope.

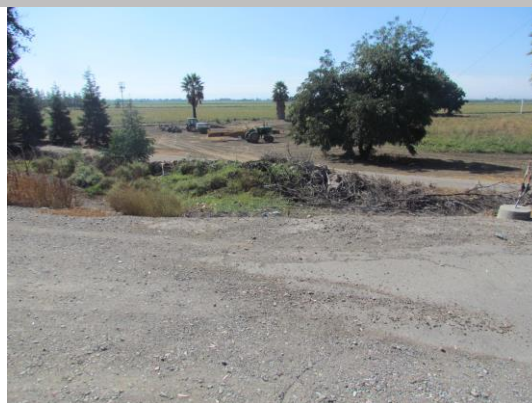
Photo 1 of 1 : FA_2018_RD0524_107_28_20180906_00049.jpg

LM Start	1.73	Rating **	U	Issue No.	28
LM End	1.73	Issue Type +	En	Location *	LS
Category	Earthen Levee			GPS Latitude/Longitude	
				Start	End
Item	Encroachments			37.926322 °	37.926322 °
				-121.326115 °	-121.326115 °
DWR ID	DWR_RD0524_01_s_2012_28				
Comment Code					
GA : Garbage					
Inspector Comment					
Large pruning piles on landside slope.

Looking west at pruning and garbage piles at landward berm.

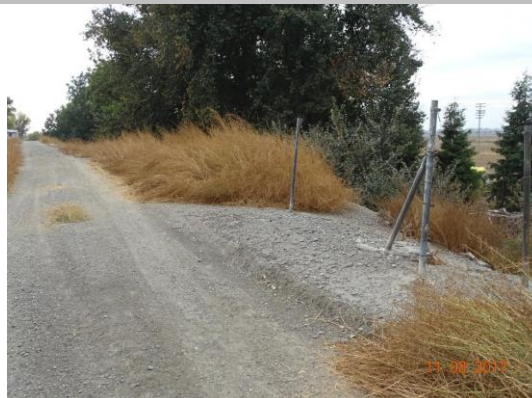
Photo 1 of 1 : FA_2018_RD0524_107_245_20180906_00339.jpg

LM Start	1.73	Rating **	U	Issue No.	245
LM End	1.75	Issue Type +	Ma	Location *	LS
Category	Earthen Levee			GPS Latitude/Longitude	
				Start	End
Item	Vegetation			37.926312 °	37.926093 °
				-121.326065 °	-121.325864 °
DWR ID	DWR_RD0524_01_f_2017_245				
Comment Code					
V2 : Remove the wild growth other than native grasses from the levee slopes.					
Inspector Comment

Looking southeast at the landside slope.

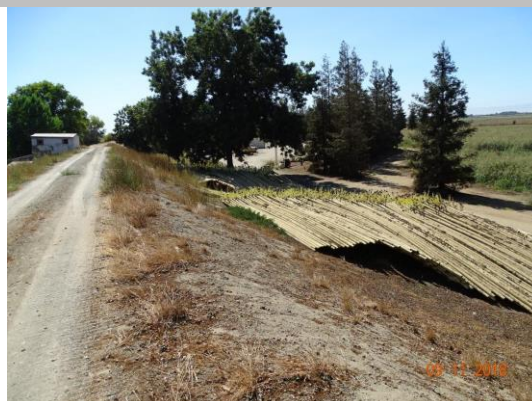
Photo 1 of 1 : FA_2018_RD0524_107_46_20180919_00474.jpg

LM Start	1.76	Rating **	U	Issue No.	46
LM End	1.81	Issue Type +	En	Location *	LS
Category	Earthen Levee			GPS Latitude/Longitude	
				Start	End
Item	Encroachments			37.925993 °	37.925397 °
				-121.325777 °	-121.325308 °
DWR ID	DWR_RD0524_01_s_2012_46				
Comment Code					
EQ : Equipment					
Inspector Comment					
Irrigation pipes stored at landward toe.

Looking southwest at irrigation pipes stored at landward slope and toe.
(Fall 2018)

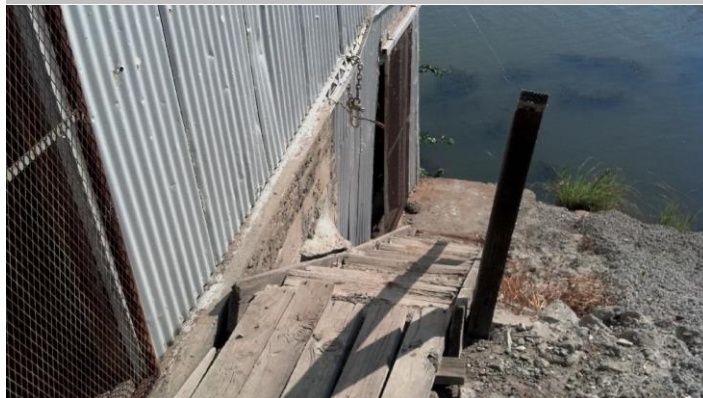
Photo 2 of 3 : UCIP_FA_2018_17847_29961.jpg

Comment Code						
Inspector Comment						
FS_ID:17847						
DS_ID:20609						
EP_NO: N/A						
Repair Type: Non-Urgent						
Crossing Status: Found						
UCIP Comments: Pipe appears abandoned and if so should be done so properly.						
FIELD_STRUCT_DESC: 14-inch irrigation pipe of an unknown material through the levee, 20 feet below the crown. 2 pumps and gate valves discharge into surge tank in pump house on the waterside (WS) slope. Concrete distribution box removed from the WS slope. Abandoned 36-inch diameter concrete standpipe on the landside (LS) toe next to service pole. [Additional Reference(s): DWR Levee Log, 2004. USACE San Joaquin O&M Manual 7, April 1964, (HLM 1.83)].						
FS Date: 8/20/2013

Steps to pump on WS slope.

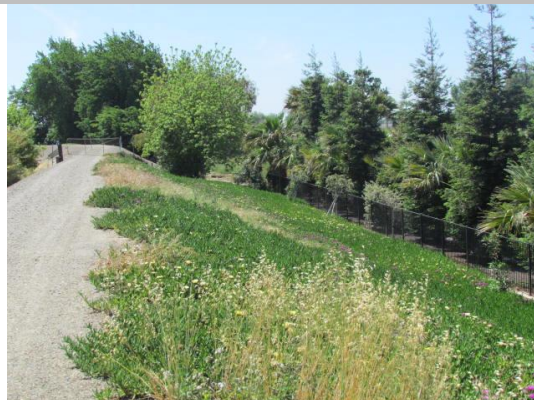
Photo 1 of 1 : FA_2018_RD0524_107_78_20180906_00135.jpg

LM Start	1.90	Rating **	U	Issue No.	78
LM End	1.94	Issue Type +	En	Location *	LS
Category	Earthen Levee			GPS Latitude/Longitude	
				Start	End
Item	Vegetation			37.924364 °	37.923805 °
				-121.324473 °	-121.324238 °
DWR ID	DWR_RD0524_01_s_2012_78				
Comment Code					
V6 : Landscaping					
Inspector Comment

Looking southwest at landscaping on landside slope. (Spring 2012)

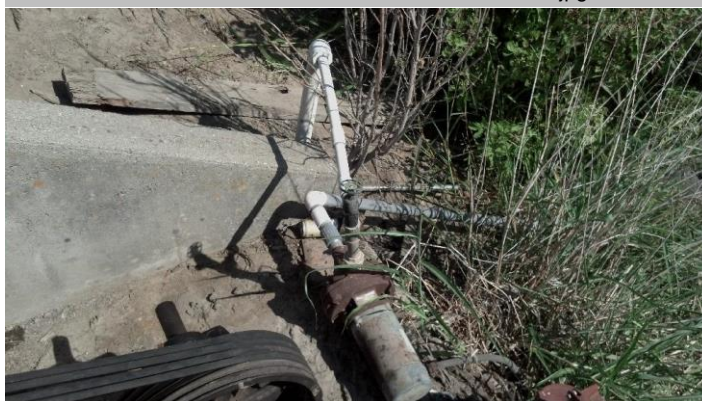
Photo 1 of 3 : UCIP_FA_2018_21872_37128.jpg

LM Start	1.99	Rating **	M	Issue No.	945
LM End	1.99	Issue Type +	En	Location *	
Category	Supplemental			GPS Latitude/Longitude	
				Start	End
Item	DWR UCIP Field Study			37.923022°	37.923022°
				-121.323953°	-121.323953°
DWR ID	24035				
Comment Code					
Inspector Comment					
FS_ID:21872 DS_ID:24035 EP_NO: N/A Repair Type: Non-Urgent Crossing Status: Found UCIP Comments: No permit identified for this crossing. FIELD_STRUCT_DESC: 3-inch polyvinyl chloride domestic non-potable water line through the levee, at an unknown depth. Pump on concrete pad at the waterside (WS) toe. FS Date: 8/20/2013

Pump on concrete pad at WS slope.

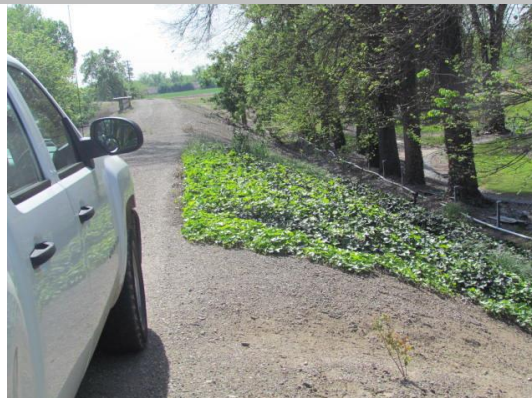
Photo 1 of 1 : FA_2018_RD0524_107_106_20180906_00168.jpg

LM Start	2.00	Rating **	U	Issue No.	106
LM End	2.00	Issue Type +	En	Location *	LS
Category	Earthen Levee			GPS Latitude/Longitude	
				Start	End
Item	Vegetation			37.922923 °	37.922923 °
				-121.323837 °	-121.323837 °
DWR ID	DWR_RD0524_01_s_2012_106				
Comment Code					
V6 : Landscaping					
Inspector Comment

Looking southwest at ground cover on landward slope.

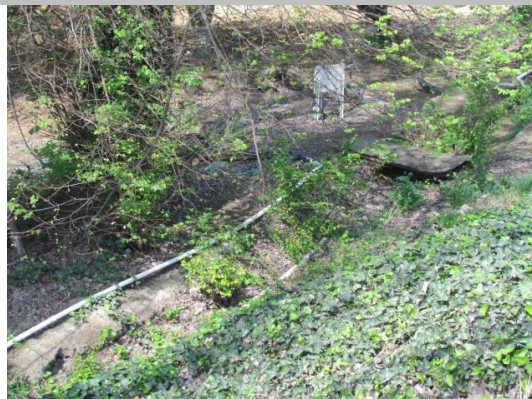
Photo 1 of 2 : FA_2018_RD0524_107_182_20180906_00240.jpg

LM Start	2.01	Rating **	M	Issue No.	182
LM End	2.04	Issue Type +	En	Location *	LS
Category	Earthen Levee			GPS Latitude/Longitude	
				Start	End
Item	Encroachments			37.922837 °	37.922514 °
				-121.323785 °	-121.323504 °
DWR ID	DWR_RD0524_01_s_2014_182				
Comment Code					
DT : Ditch					
Inspector Comment					
Old irrigation ditch at the landside toe should be removed.

Looking northwest at an old irrigation ditch at landward toe.

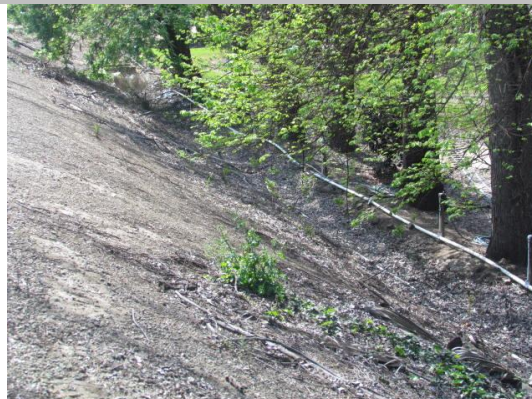
Photo 2 of 2 : FA_2018_RD0524_107_182_20180906_00241.jpg

Looking southwest at an old irrigation ditch at landward toe.

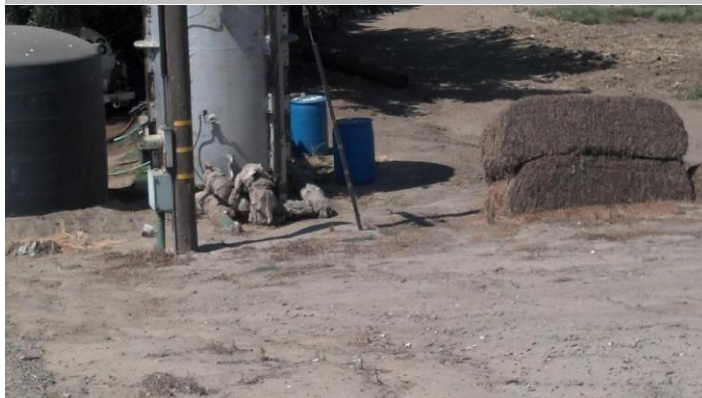
Photo 1 of 3 : UCIP_FA_2018_21895_37142.jpg

LM Start	2.07	Rating **	M	Issue No.	947
LM End	2.07	Issue Type +	En	Location *	
Category	Supplemental			GPS Latitude/Longitude	
				Start	End
Item	DWR UCIP Field Study			37.922080°	37.922080°
				-121.323118°	-121.323118°
DWR ID	24038				
Comment Code					
Inspector Comment					
FS_ID:21895 DS_ID:24038 EP_NO: N/A Repair Type: Non-Urgent Crossing Status: Found UCIP Comments: No permit identified for this crossing. FIELD_STRUCT_DESC: 6-inch steel irrigation pipe through the levee, at an unknown depth. Vent, meter, butterfly valve, and pump at pump house on the waterside (WS) slope. FS Date: 8/20/2013

Steel irrigation line visible in front of tank to right of powerpole off LS toe.

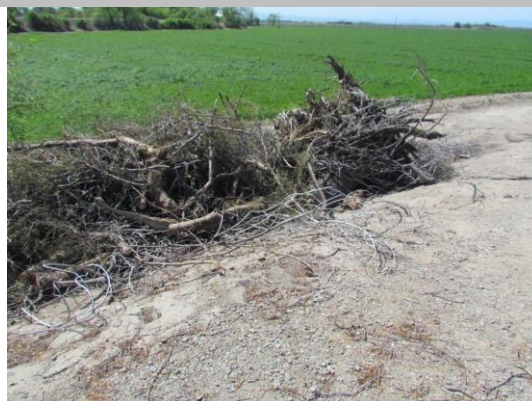
Photo 1 of 1 : FA_2018_RD0524_107_203_20180906_00269.jpg

LM Start	2.27	Rating **	U	Issue No.	203
LM End	2.27	Issue Type +	En	Location *	LS
Category	Earthen Levee			GPS Latitude/Longitude	
				Start	End
Item	Encroachments			37.920327 °	37.920327 °
				-121.320175 °	-121.320175 °
DWR ID	DWR_RD0524_01_f_2016_203				
Comment Code					
PR : Prunings					
Inspector Comment					
Large pruning pile on landside slope and toe.

Looking west at pruning pile on waterward slope.

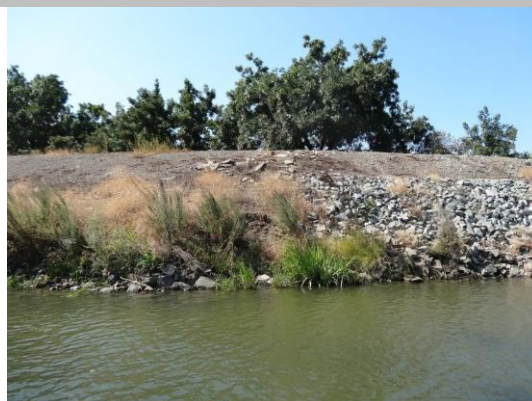
Photo 1 of 3 : FA_2018_RD0524_107_70_20180906_00120.jpg

LM Start	2.30	Rating **	M	Issue No.	70
LM End	2.30	Issue Type +	Ma	Location *	WS
Category	Supplemental			GPS Latitude/Longitude	
				Start	End
Item	DWR Erosion Survey			37.920150 °	37.920150 °
				-121.319700 °	-121.319700 °
DWR ID	RD0524U01RM42.9				
Comment Code					
Inspector Comment					
09/13/2017: The erosion is located immediately upstream of a repaired levee section. [2017 Site ID:RD0524U01RM42.9]

Front view of the pocket erosion.

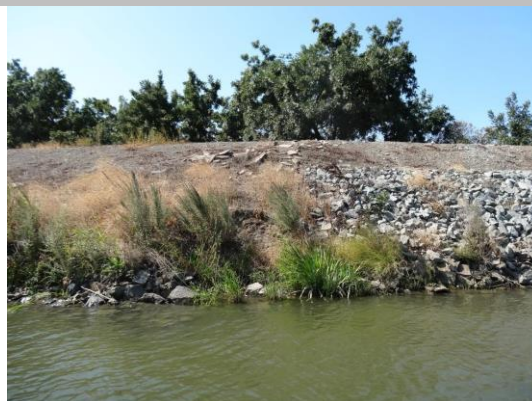
Photo 2 of 3 : FA_2018_RD0524_107_70_20180906_00121.jpg

Close view of the erosion.

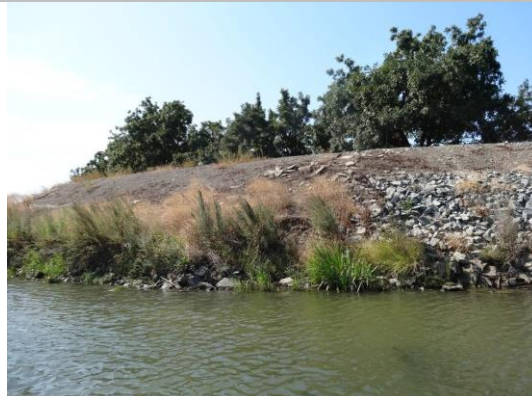
Photo 3 of 3 : FA_2018_RD0524_107_70_20180906_00122.jpg

LM Start	2.30	Rating **	M	Issue No.	70 (cont)	
LM End	2.30	Issue Type +	Ma	Location *	WS	
Category	Supplemental			GPS Latitude/Longitude		
				Start		End
Item	DWR Erosion Survey			37.920150 °	37.920150 °	
				-121.319700 °	-121.319700 °	
DWR ID	RD0524U01RM42.9					
Comment Code						
Inspector Comment						
09/13/2017: The erosion is located immediately upstream of a repaired levee section. [2017 Site ID:RD0524U01RM42.9]

Front view of the erosion.

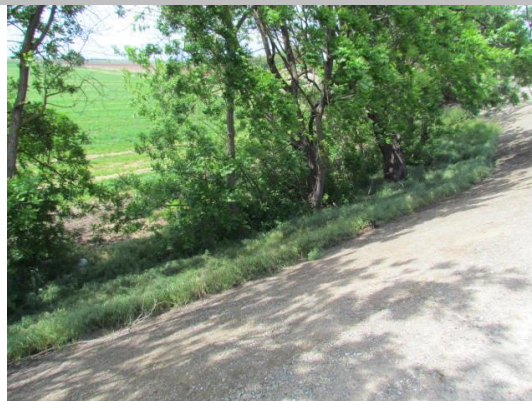
Photo 1 of 1 : FA_2018_RD0524_107_107_20180906_00169.jpg

LM Start	2.33	Rating **	M	Issue No.	107
LM End	2.33	Issue Type +	Ma	Location *	LS
Category	Earthen Levee			GPS Latitude/Longitude	
				Start	End
Item	Trim / Thin Trees			37.919742 °	37.919742 °
				-121.319623 °	-121.319623 °
DWR ID	DWR_RD0524_01_s_2012_107				
Comment Code					
T1 : Trim trees to at least five feet above ground level.					
Inspector Comment

Looking northwest at untrimmed trees at landward toe.

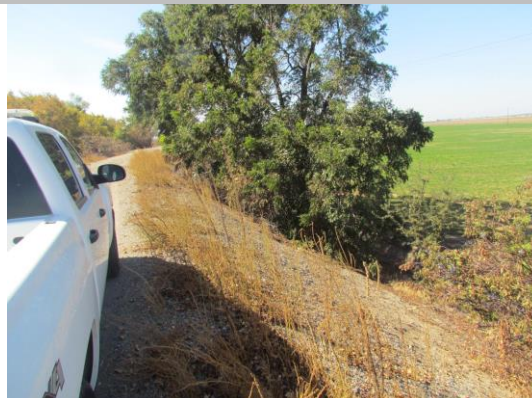
Photo 1 of 1 : FA_2018_RD0524_107_80_20180906_00140.jpg

LM Start	2.45	Rating **	U	Issue No.	80
LM End	2.45	Issue Type +	Ma	Location *	LS
Category	Earthen Levee			GPS Latitude/Longitude	
				Start	End
Item	Trim / Thin Trees			37.918480 °	37.918480 °
				-121.321114 °	-121.321114 °
DWR ID	DWR_RD0524_01_s_2012_80				
Comment Code					
T1 : Trim trees to at least five feet above ground level.					
Inspector Comment					
Untrimmed tree on landside slope.

Looking south at untrimmed tree on landward slope.

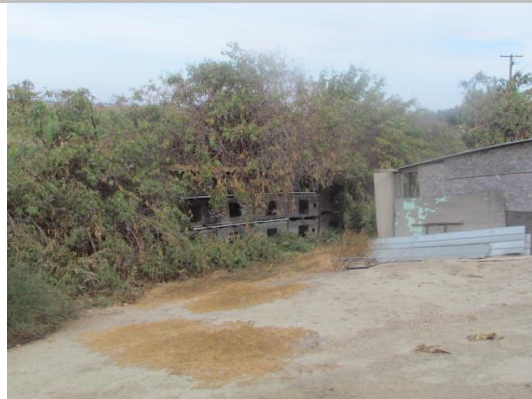
Photo 1 of 2 : FA_2018_RD0524_107_42_20180906_00070.jpg

LM Start	2.56	Rating **	U	Issue No.	42
LM End	2.56	Issue Type +	En	Location *	LS
Category	Earthen Levee			GPS Latitude/Longitude	
				Start	End
Item	Encroachments			37.917673 °	37.917673 °
				-121.322718 °	-121.322718 °
DWR ID	DWR_RD0524_01_s_2012_42				
Comment Code					
BU : Building					
Inspector Comment					
Animal pens on landside slope and toe.

Looking west at animal pens on landside toe. (Fall 2012)

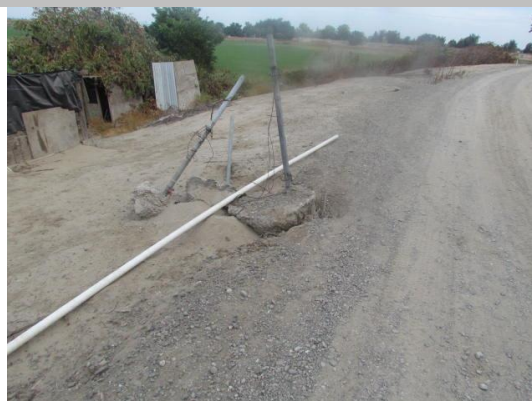
Photo 1 of 1 : FA_2018_RD0524_107_12_20180906_00018.jpg

LM Start	2.57	Rating **	M	Issue No.	12
LM End	2.57	Issue Type +	En	Location *	LS
Category	Earthen Levee			GPS Latitude/Longitude	
				Start	End
Item	Encroachments			37.917538 °	37.917538 °
				-121.322757 °	-121.322757 °
DWR ID	DWR_RD0524_01_f_2012_12				
Comment Code					
PO : Pole					
Inspector Comment					
Old fence poles on landside shoulder and slope should be removed. 4/3/17: Old post removed, a new larger post replacing the old post

Looking northwest at fence poles on landside shoulder.

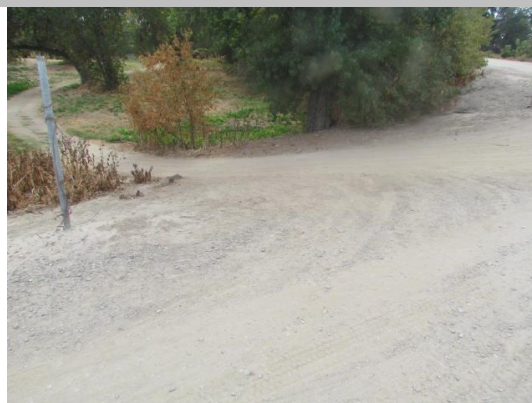
Photo 1 of 1 : FA_2018_RD0524_107_7_20180906_00015.jpg

LM Start	2.58	Rating **	M	Issue No.	7
LM End	2.58	Issue Type +	En	Location *	LS
Category	Earthen Levee			GPS Latitude/Longitude	
				Start	End
Item	Encroachments			37.917431 °	37.917431 °
				-121.322780 °	-121.322780 °
DWR ID	DWR_RD0524_01_f_2012_7				
Comment Code					
RA : Ramp					
Inspector Comment					
Ramp due to land owner traffic.

Looking southeast at unauthorized ramp on waterside slope.

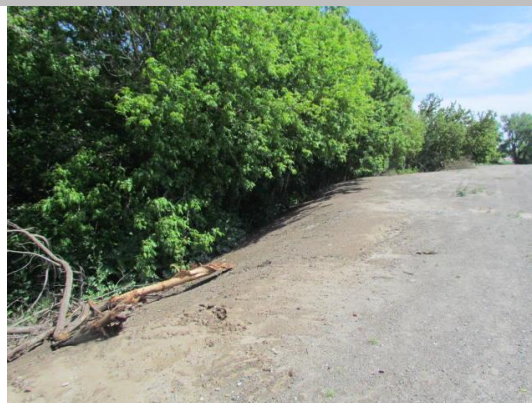
Photo 1 of 1 : FA_2018_RD0524_107_185_20180906_00245.jpg

LM Start	2.60	Rating **	U	Issue No.	185
LM End	2.64	Issue Type +	Ma	Location *	WS
Category	Earthen Levee			GPS Latitude/Longitude	
				Start	End
Item	Trim / Thin Trees			37.917152°	37.916807°
				-121.322582°	-121.322069°
DWR ID	DWR_RD0524_01_s_2014_185				
Comment Code					
T2 : Thin trees to allow visibility of the ground and room to flood fight.					
Inspector Comment

Looking northwest at untrimmed trees on landward slope and toe.

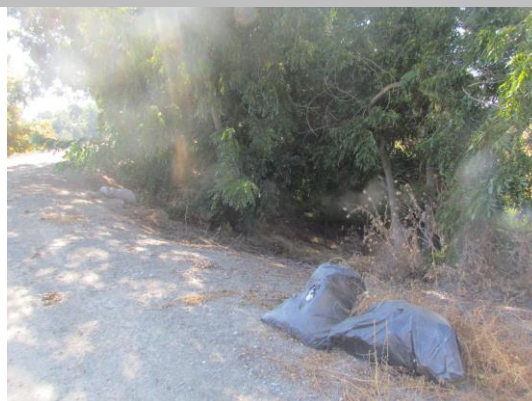
Photo 1 of 1 : FA_2018_RD0524_107_918_20180906_00361.jpg

LM Start	2.65	Rating **	U	Issue No.	918
LM End	2.66	Issue Type +	Ma	Location *	LS
Category	Earthen Levee			GPS Latitude/Longitude	
				Start	End
Item	Trim / Thin Trees			37.916718 °	37.916502 °
				-121.322020 °	-121.321980 °
DWR ID	DWR_RD0524_01_s_2012_918				
Comment Code					
T1 : Trim trees to at least five feet above ground level.					
Inspector Comment					
Untrimmed trees on landside slope and toe.

Looking south at untrimmed trees on landward slope.

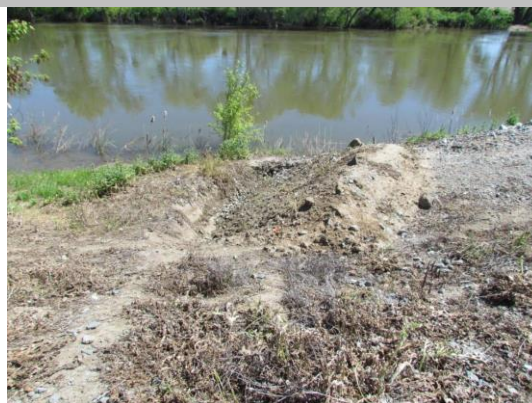
Photo 1 of 2 : FA_2018_RD0524_107_920_20180906_00362.jpg

LM Start	2.65	Rating **	U	Issue No.	920
LM End	2.65	Issue Type +	En	Location *	WS
Category	Earthen Levee			GPS Latitude/Longitude	
				Start	End
Item	Encroachments			37.916698 °	37.916698 °
				-121.322007 °	-121.322007 °
DWR ID	DWR_RD0524_01_s_2012_920				
Comment Code					
RA : Ramp					
Inspector Comment					
Hole dug at base of ramp on river side.

Looking east at hole at the end of ramp on waterward slope.

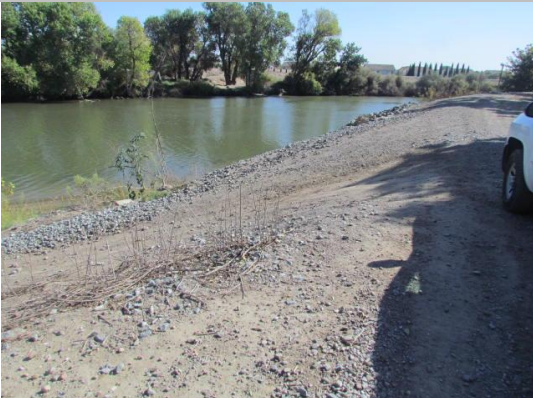
Photo 2 of 2 : FA_2018_RD0524_107_920_20180906_00363.jpg

Looking southeast at unauthorized ramp on waterside slope. (Spring 2016)

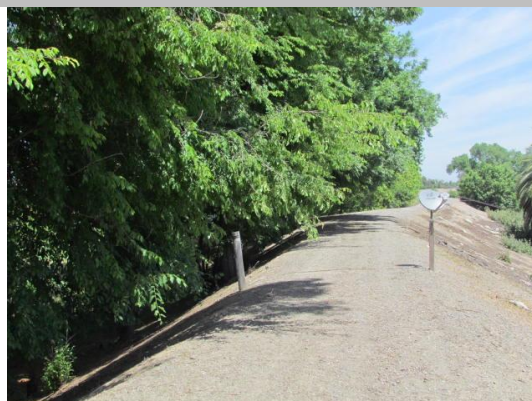
Photo 2 of 2 : FA_2018_RD0524_107_264_20180906_00353.jpg

LM Start	2.70	Rating **	M	Issue No.	264 (cont)	
LM End	2.76	Issue Type +	Ma	Location *	LS	
Category	Earthen Levee			GPS Latitude/Longitude		
				Start		End
Item	Trim / Thin Trees			37.915945°	37.915276°	
				-121.322290°	-121.322808°	
DWR ID	DWR_RD0524_01_s_2012_264					
Comment Code						
T2 : Thin trees to allow visibility of the ground and room to flood fight.						
Inspector Comment						
Untrimmed trees along landside slope and toe. Additionally, trim over hanging trees at least 12 feet above ground level.

Looking north at dense trees overhanging levee crown.

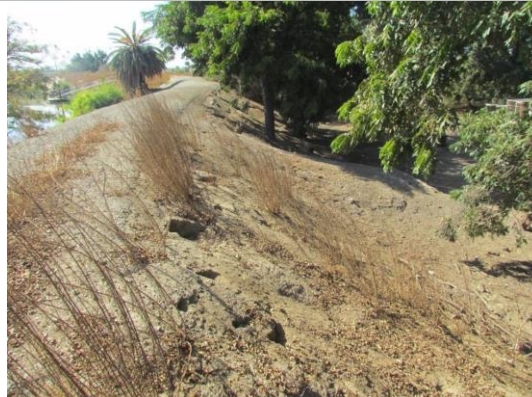
Photo 1 of 2 : FA_2018_RD0524_107_219_20180906_00287.jpg

LM Start	2.77	Rating **	U	Issue No.	219
LM End	2.80	Issue Type +	Ma	Location *	LS
Category	Earthen Levee			GPS Latitude/Longitude	
				Start	End
Item	Animal Control			37.915195 °	37.915052 °
				-121.322930 °	-121.323430 °
DWR ID	DWR_RD0524_01_f_2016_219				
Comment Code					
A1 : Exterminate rodents and backfill and compact or grout burrows.					
Inspector Comment					
Several large rodent holes on landside slope.

Looking south at several rodent holes on landward slope.

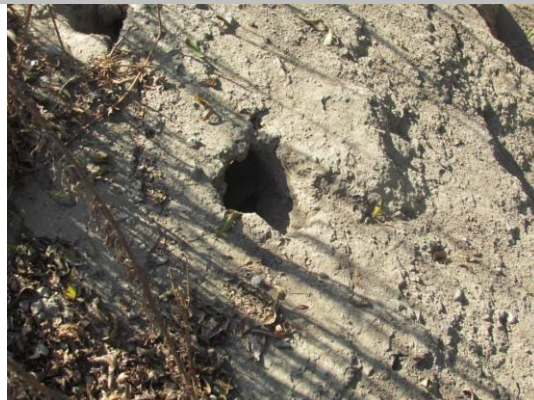
Photo 2 of 2 : FA_2018_RD0524_107_219_20180906_00288.jpg

LM Start	2.77	Rating **	U	Issue No.	219 (cont)	
LM End	2.80	Issue Type +	Ma	Location *	LS	
Category	Earthen Levee			GPS Latitude/Longitude		
				Start		End
Item	Animal Control			37.915195 °		37.915052 °
				-121.322930 °		-121.323430 °
DWR ID	DWR_RD0524_01_f_2016_219					
Comment Code						
A1 : Exterminate rodents and backfill and compact or grout burrows.						
Inspector Comment						
Several large rodent holes on landside slope.

Looking at typical rodent hole on waterward slope.

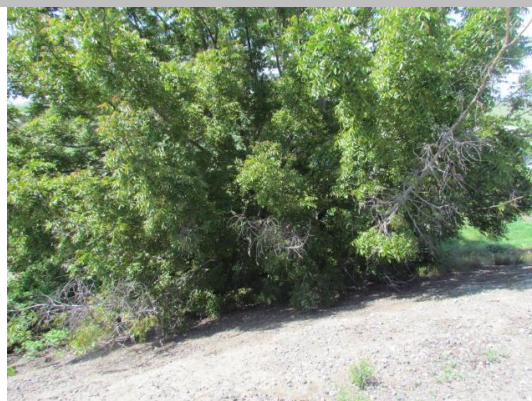
Photo 1 of 1 : FA_2018_RD0524_107_209_20180906_00275.jpg

LM Start	2.87	Rating **	U	Issue No.	209
LM End	2.87	Issue Type +	Ma	Location *	LS
Category	Earthen Levee			GPS Latitude/Longitude	
				Start	End
Item	Trim / Thin Trees			37.914257 °	37.914257 °
				-121.324317 °	-121.324317 °
DWR ID	DWR_RD0524_01_s_2016_209				
Comment Code					
T1 : Trim trees to at least five feet above ground level.					
Inspector Comment					
Untrimmed walnut tree on landside slope and toe.

Looking northwest at untrimmed tree at landward toe.

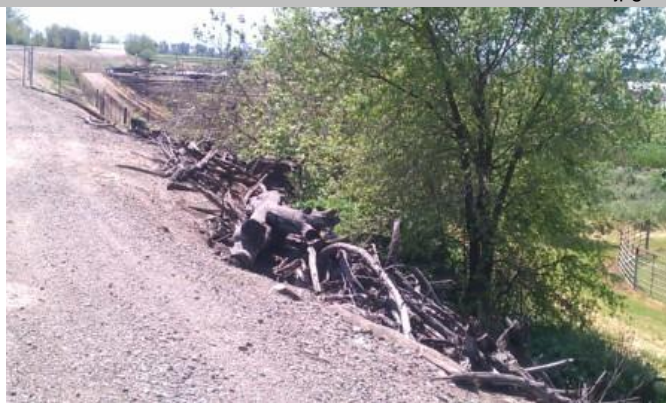
Photo 1 of 1 : FA_2018_RD0524_107_50_20180906_00091.jpg

LM Start	2.90	Rating **	U	Issue No.	50
LM End	2.92	Issue Type +	Ma	Location *	LS
Category	Earthen Levee			GPS Latitude/Longitude	
				Start	End
Item	Encroachments			37.913767 °	37.913486 °
				-121.324427 °	-121.324428 °
DWR ID	DWR_RD0524_01_s_2012_50				
Comment Code					
PR : Prunings					
Inspector Comment

Looking southwest at prunings on landside slope.

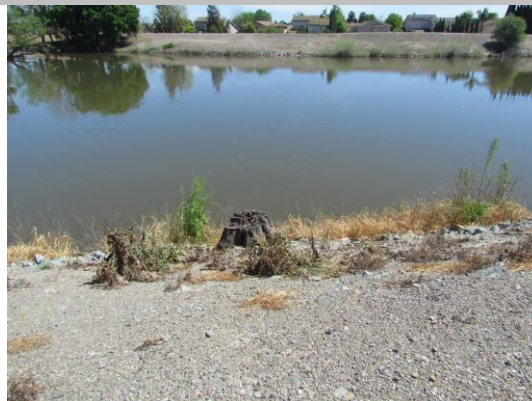
Photo 1 of 1 : FA_2018_RD0524_107_161_20180906_00214.jpg

LM Start	2.91	Rating **	U	Issue No.	161
LM End	2.91	Issue Type +	Ma	Location *	WS
Category	Earthen Levee			GPS Latitude/Longitude	
				Start	End
Item	Trim / Thin Trees			37.913733 °	37.913733 °
				-121.324398 °	-121.324398 °
DWR ID	DWR_RD0524_01_s_2017_161				
Comment Code					
T5 : Tree stumps.					
Inspector Comment

Looking east at large tree stump on waterward shoulder.

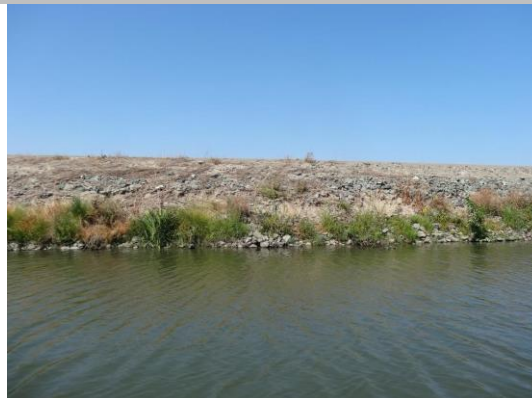
Photo 1 of 4 : FA_2018_RD0524_107_71_20180906_00123.jpg

LM Start	2.96	Rating **	U	Issue No.	71
LM End	2.96	Issue Type +	Ma	Location *	WS
Category	Supplemental			GPS Latitude/Longitude	
				Start	End
Item	DWR Erosion Survey			37.913010 °	37.913010 °
				-121.324490 °	-121.324490 °
DWR ID	RD0524U01RM43.52				
Comment Code					
Inspector Comment					
09/13/2017: A new pocket erosion observed at the eroison site, next to an irrigation pipe.					
07/25/2016: No significant change observed.					
06/24/2015: No significant change observed.					
06/19/2014: No significant change observed.					
08/13/2013: No significant change observed.					
08/07/2012: The site was first reported in 2012 spring levee inspection report. [2017 Site ID:RD0524U01RM43.52]

Front view of the erosion.

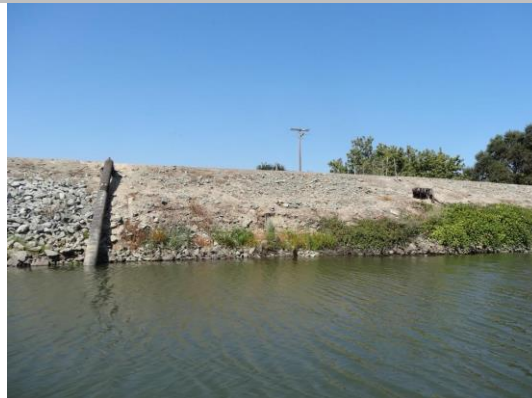
Photo 2 of 4 : FA_2018_RD0524_107_71_20180906_00124.jpg

View of the newly developed pocket erosion next to an irrigation pipe.

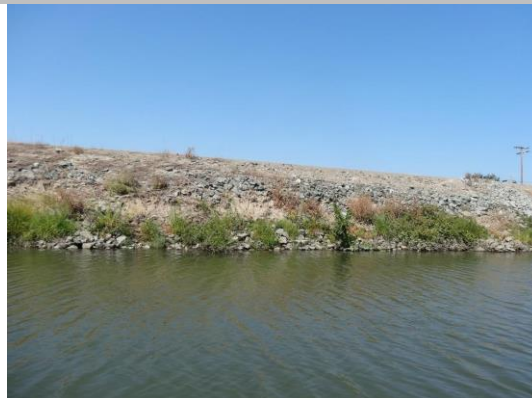
Photo 3 of 4 : FA_2018_RD0524_107_71_20180906_00125.jpg

LM Start	2.96	Rating **	U	Issue No.	71 (cont)	
LM End	2.96	Issue Type +	Ma	Location *	WS	
Category	Supplemental			GPS Latitude/Longitude		
				Start	End	
Item	DWR Erosion Survey			37.913010 °	37.913010 °	
				-121.324490 °	-121.324490 °	
DWR ID	RD0524U01RM43.52					
Comment Code						
Inspector Comment						
09/13/2017: A new pocket erosion observed at the eroison site, next to an irrigation pipe.						
07/25/2016: No significant change observed.						
06/24/2015: No significant change observed.						
06/19/2014: No significant change observed.						
08/13/2013: No significant change observed.						
08/07/2012: The site was first reported in 2012 spring levee inspection report. [2017 Site ID:RD0524U01RM43.52]

Close view of the erosion.

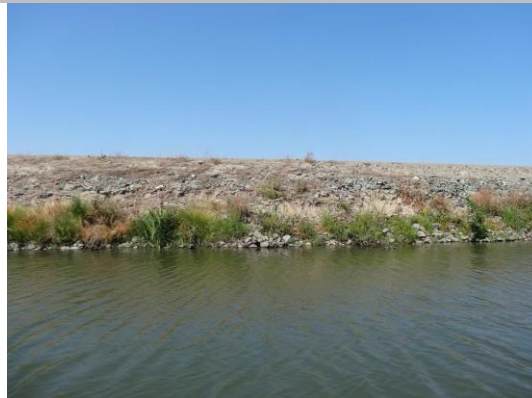
Photo 4 of 4 : FA_2018_RD0524_107_71_20180906_00126.jpg

Close view of the erosion. Note the new pocket erosion next to the irrigation pipe on the site.
